FINAL REPORT OF PHASE II

HIGH SHOCK FM TRANSMITTER

CONTRACT NUMBER NAS1-5042

14 MAY 1966

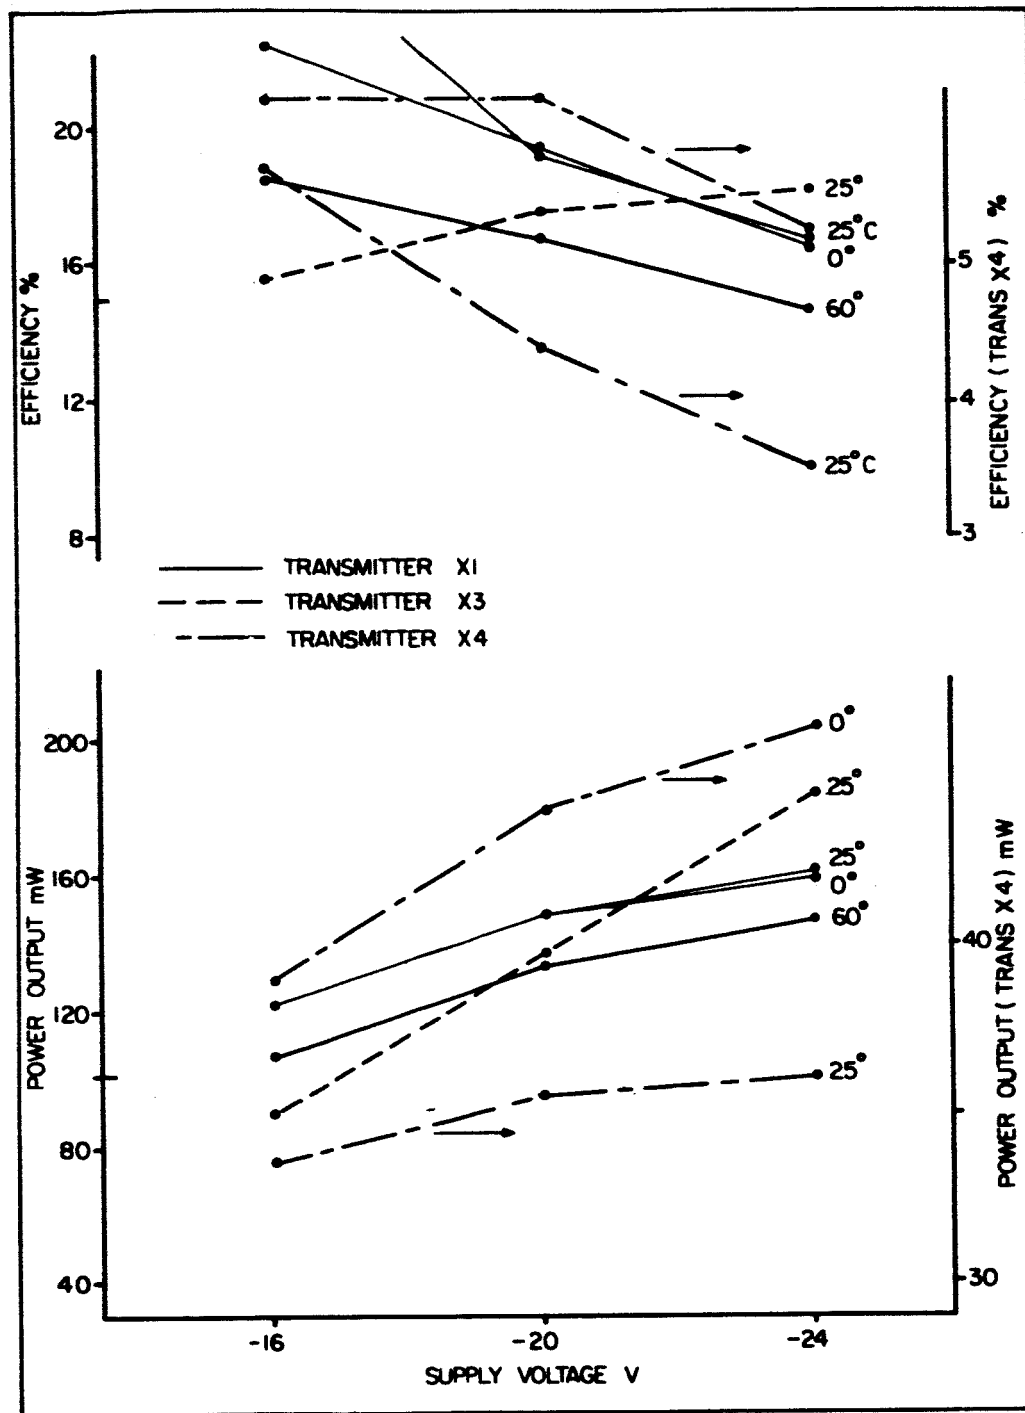
Figure 33. Power and Efficiency Curves for Transmitters X1, X3 and X4

22 Figures 33 and 34 give the power output and efficiency curves at various supply voltages and constant case temperatures. The power outputs for transmitters X1, X2 and X3 are somewhat below 100 milliwatts at the low supply voltage. The impact tests on transmitter X2 appeared to have lowered its output somewhat. The output of X4 is very low, especially at the lowest supply voltage and the higher temperatures. The efficiencies for all the transmitters, except X4, were generally above the required 15 per cent.

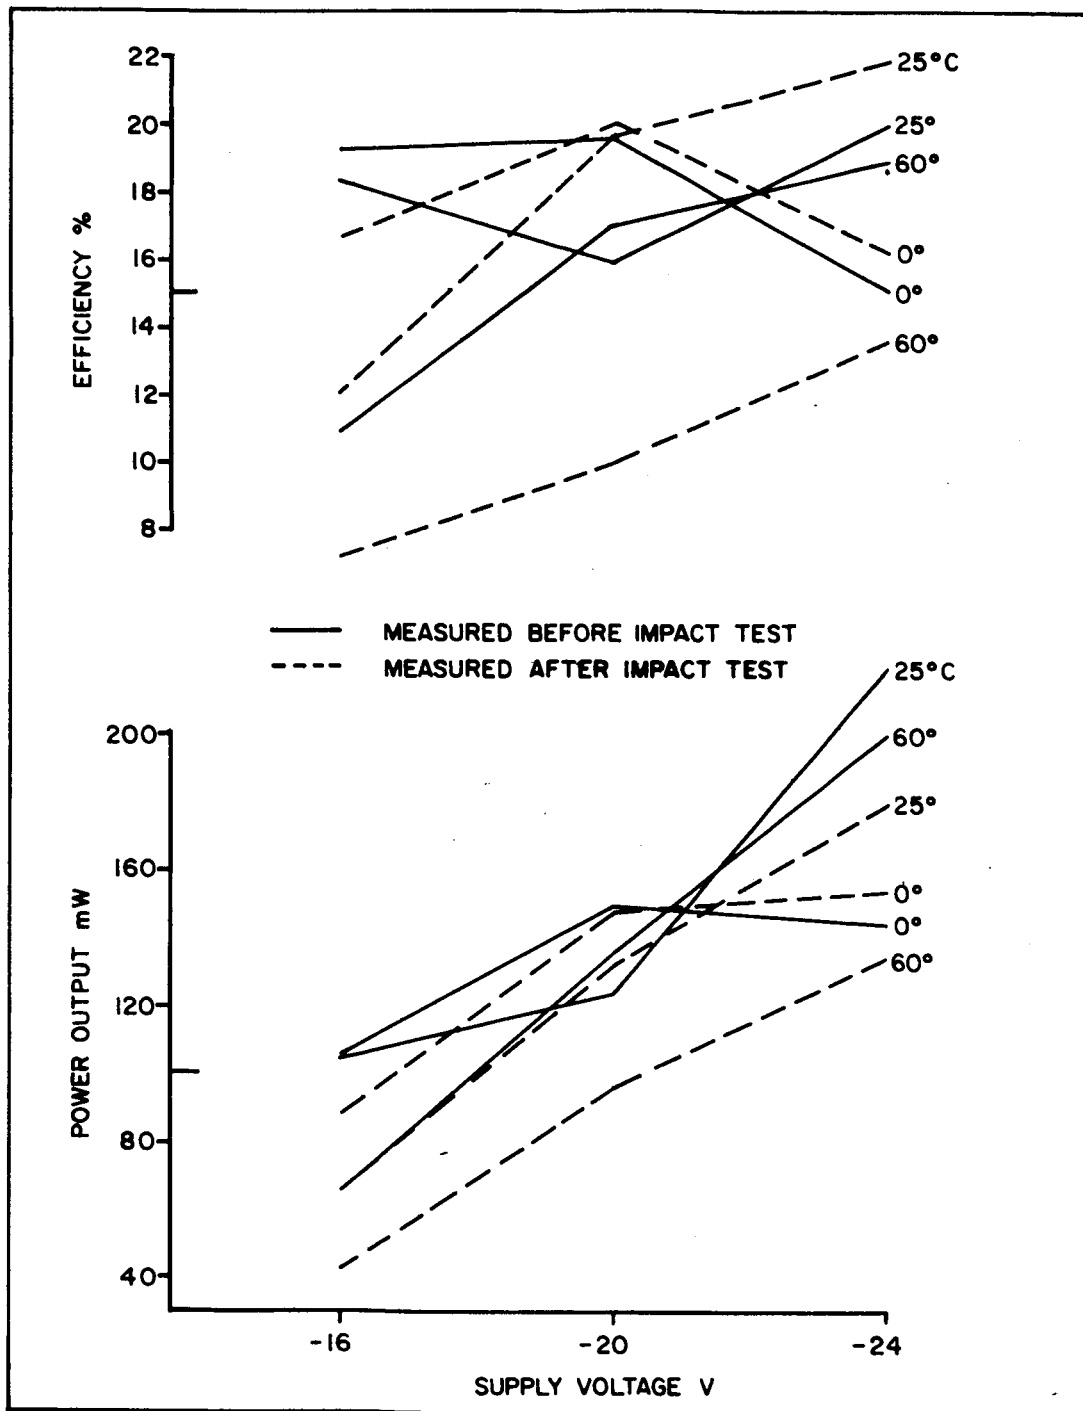
Figure 34. Power and Efficiency Curves for Transmitter X2

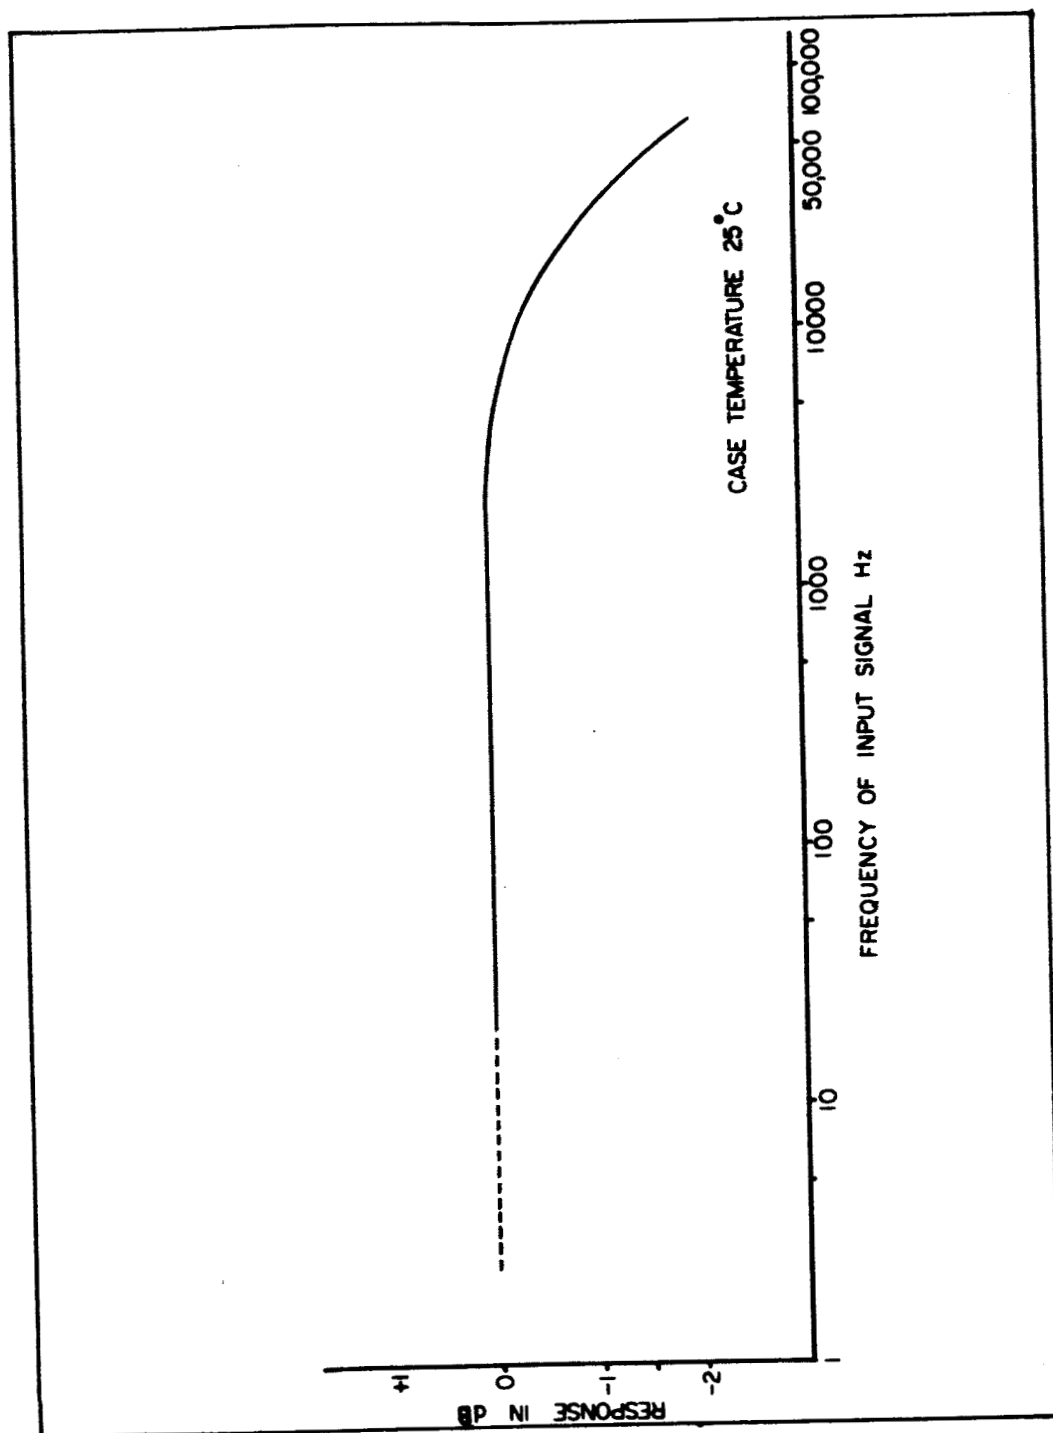
Figure 35. Typical Modulation Bandwidth Curve for the Final Phase II Transmitters
